### Flood of North Lakhimpur vis-a-vis Ranganadi Hydropower Project

**INDIAN INSTITUTE OF TECHNOLOGY GUWAHATI**  
**North Guwahati, Guwahati – 781 039**  
**ASSAM, INDIA**

**Feb 2018**

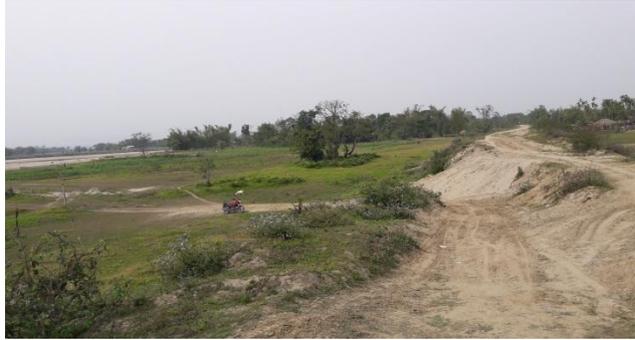
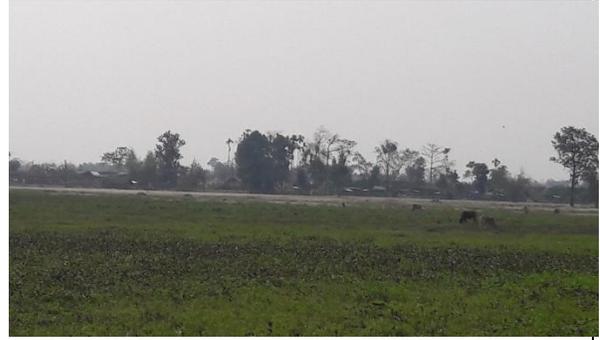
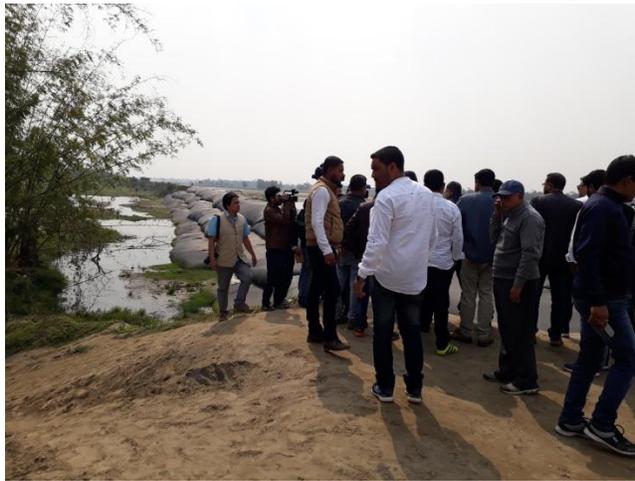
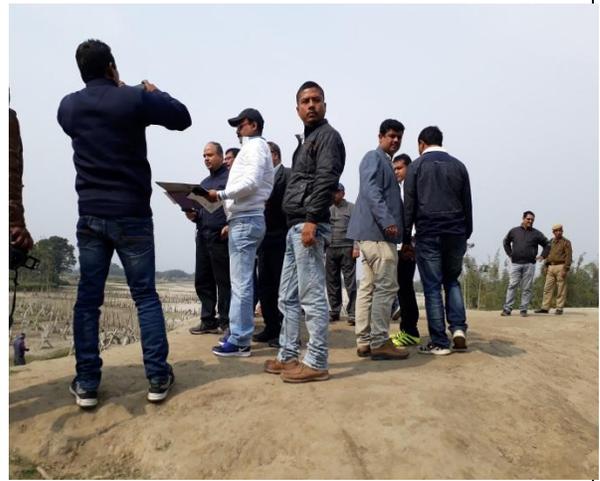
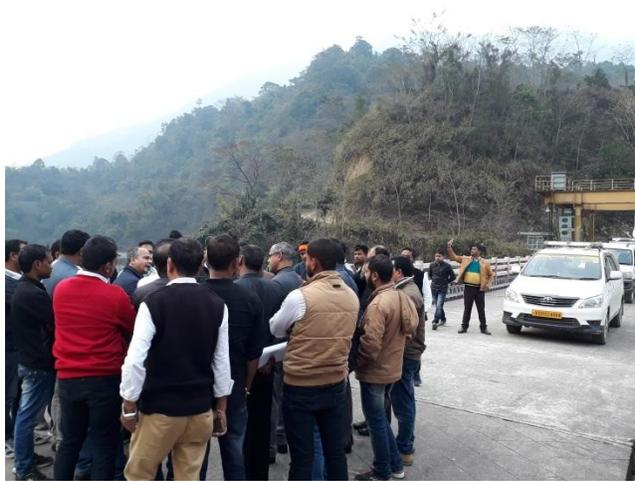
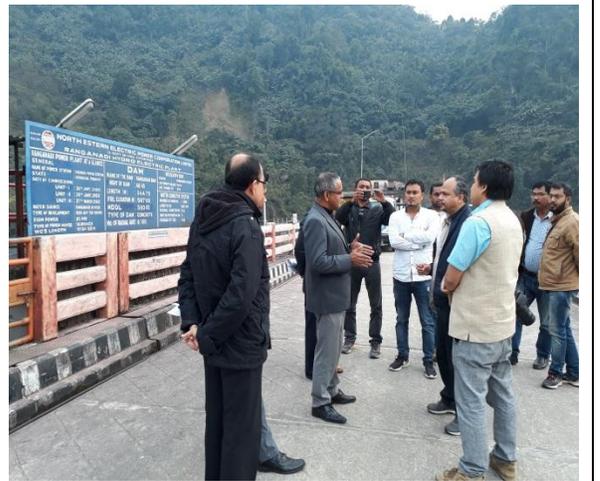
**ANNEXURE 1: Photograph Taken During Field Visit**

- 3.8 There is habitation very close to the embankment (Annexure-1) and also within the embankment as well. In response to our queries, members of AJYCP responded that some of them were staying there even before construction of the embankment. Moreover, Ranganadi Hydel project being an inter-basin-transfer project, Ranganadi remain almost dry in most of the time, and therefore, it has become a grazing ground for the domestic animals of people residing both inside outside the embankment.

- 4.1 After promoting sedimentation using porcupine screen, the Bogolijan breach point was closed by WR department using Mega Geo Container in the month of August 2017 to stop farther release of flood water (photo in Annexure-1). However, the work needs to be completed by covering it with compacted soils so as to bring the top to the formation level with proper dimensions.
- 4.2 The Bogolijan embank was appearing to be of inadequate size and responding to a query, Engineers of WR department informed that raising and strengthening of this embankment was taken up under FMP scheme and though raising was almost completed maintaining proposed gradient (1:2 in the river side and 1:3 in the country side) and covering it by geo-mattress was not possible in some portion because of paucity of fund.

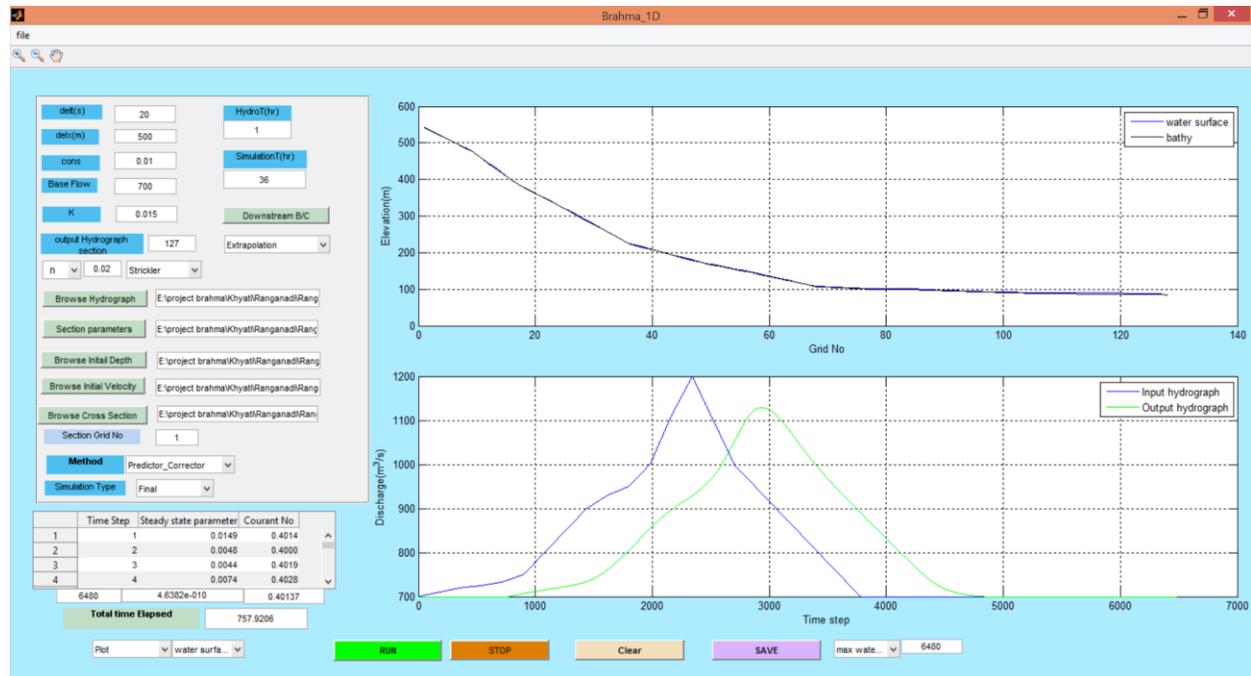
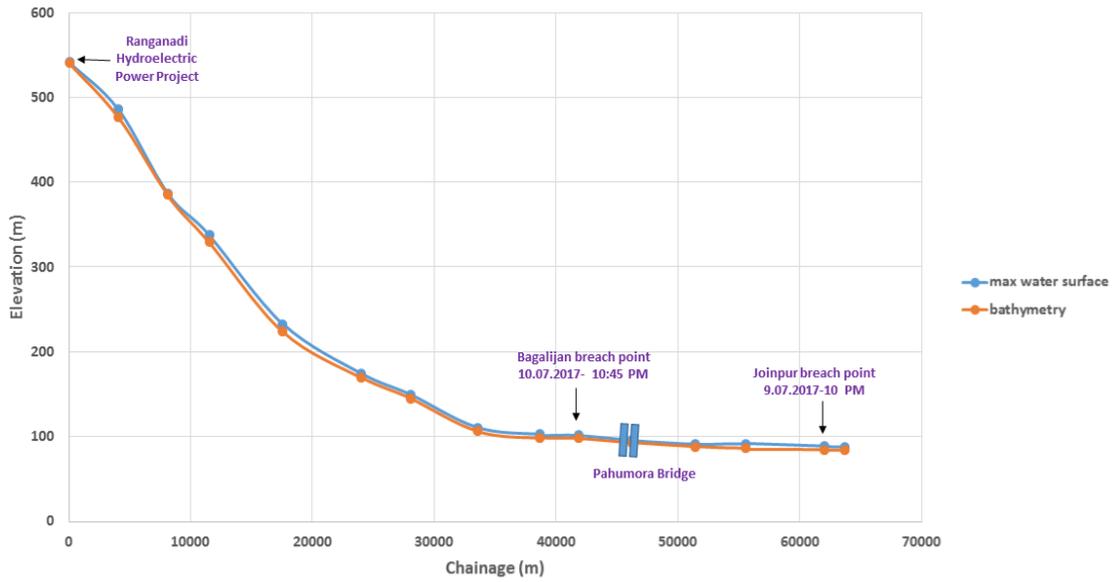
Flood Attenuation Results from BRAHMA Model

- 5.6 Hydrodynamic component of BRAHMA (Braided River Aid Hydro-Morphological Analyser) model was applied using approximate bathymetry to have an idea about the flood attenuation possibility till the released peak flow reaches the downstream. Model study with approximate bathymetry has shown peak flow attenuation in the order of just 80cumec for a hypothetical hydrograph increasing from 700cumec to 1200cumec in 12 hours. The peak movement time is found to be in the order of 4:00hours and it moves with very high velocity in order of 6.00 to 7.00m/s in the hilly terrain and in the plains it is in the order of 2.4 m/s. The flow depth crosses the natural bank to touch the embankment. It is worth mentioning that this exercise is done with approximate bathymetry and with approximate outflow hydrograph and is used to understand the hydrodynamic characteristic and the trend and therefore, may not be considered as exact values (Model Study Results in Annexure-2). Detail bathymetric survey is necessary for accurate result.
