Sub: Assam Heavy Rains 2022- Near Real Time Flood Mapping using satellite data

Assam Heavy Rains – 2021

Flood Inundated Areas in Part of Cachar District, Assam State

Based on the analysis of Indian EO satellite data of 19-May-2022

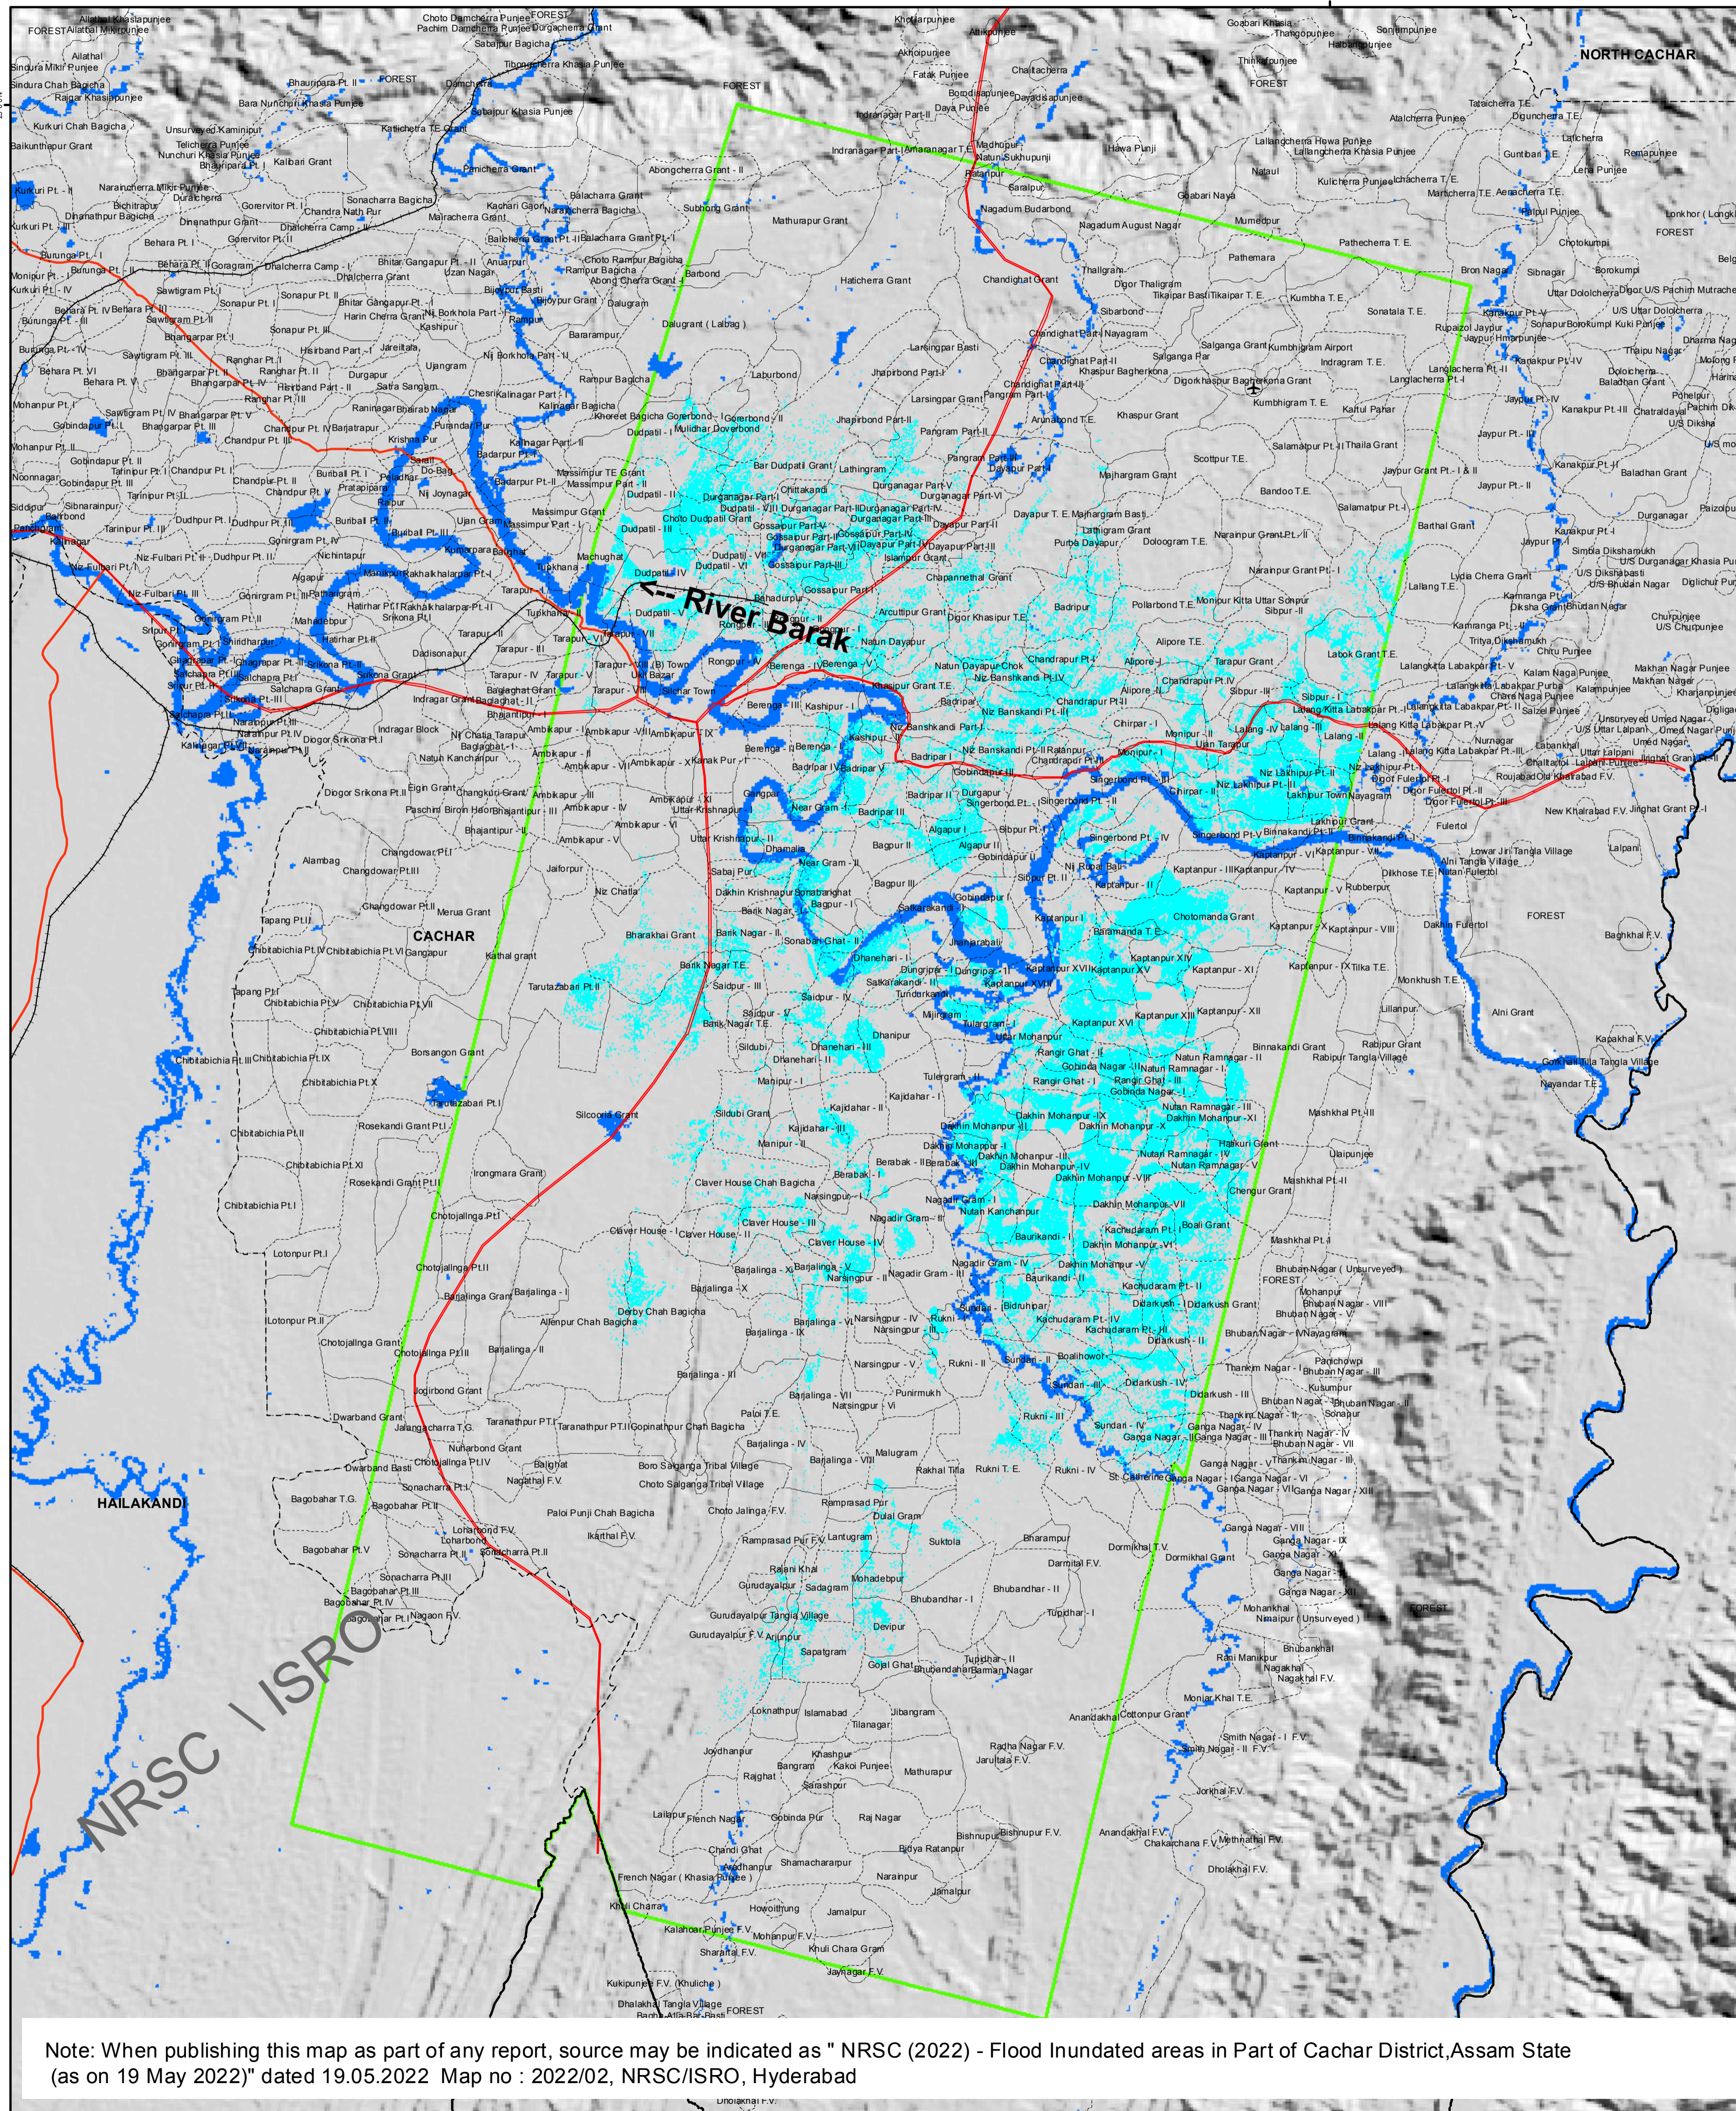
DISASTER EVENT ID: 01-FL-2022-ASSAM
MAP ID: 2022/2

This map highlights the inundation in part of Cachar district of Assam State as on 19 May 2022.

Flood inundation may include rain water accumulation / flood water in low lying areas.

Satellite data is rectified and flood inundation layer is extracted. Further, flood inundation map was composed for part of Cachar district, Assam state based on the analysis of Indian EO satellite data of 19th May 2022. The flood inundation layer is integrated with district boundary layer, for extracting district-wise flood inundation statistics which are shown in the Table-2.

- Satellite data covers part of Assam State
- Major inundation was observed in Cachar district.
- The Inundation may include water accumulation in low lying areas due to heavy incessant rainfall.
