Sub: Assam Heavy Rains 2023- Near Real Time Flood Mapping using satellite data

Mapping and Monitoring of Flood situation in Assam State during 2023

Flood Inundation Areas in Part of ASSAM State

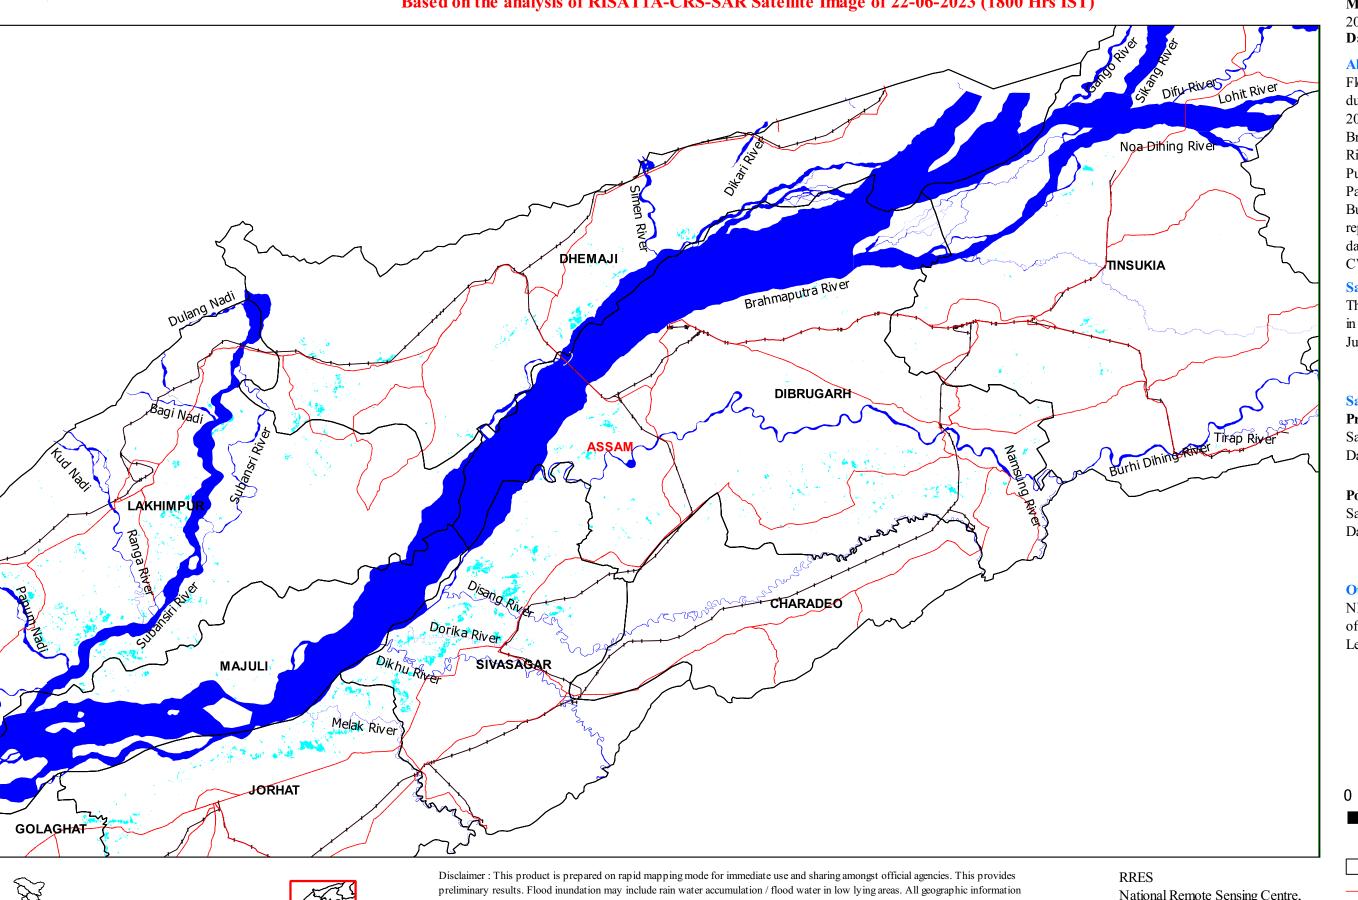
Map ID:MAP ID:

Based on the analysis of RISAT1A-CRS-SAR Satellite Image of 22-06-2023 (1800 Hrs IST)

This map highlights the inundation in 8 districts of Assam as on 22-Jun-2023 (1800 Hrs).

Satellite: RISAT1A-CRS-SAR Date of Pass: 22-06-2023

Satellite data is rectified and flood inundation layer is extracted. Further, flood inundation map was composed for part of Assam state based on the analysis of RISAT-1A SAR CRS satellite dataset of 22nd June 2023 (1800 Hrs). The cumulative flood inundation layer is integrated with district boundary layer, for extracting district-wise flood inundation statistics which are shown in the Table-2.

- Satellite data covers part of Assam State
- Major inundation was observed in Sibsagar, Lakhimpur* and Jorhat districts.
- The Inundation may include water accumulation in low lying areas due to heavy incessant rainfall.
